A Submission to the Inquiry into Forestry Related Impacts of Cyclone Gabrielle

Don Miller (Formerly Scientist Water and Soil Divn, MWD/DSIR and Geotechnical Consultant.) March 2023

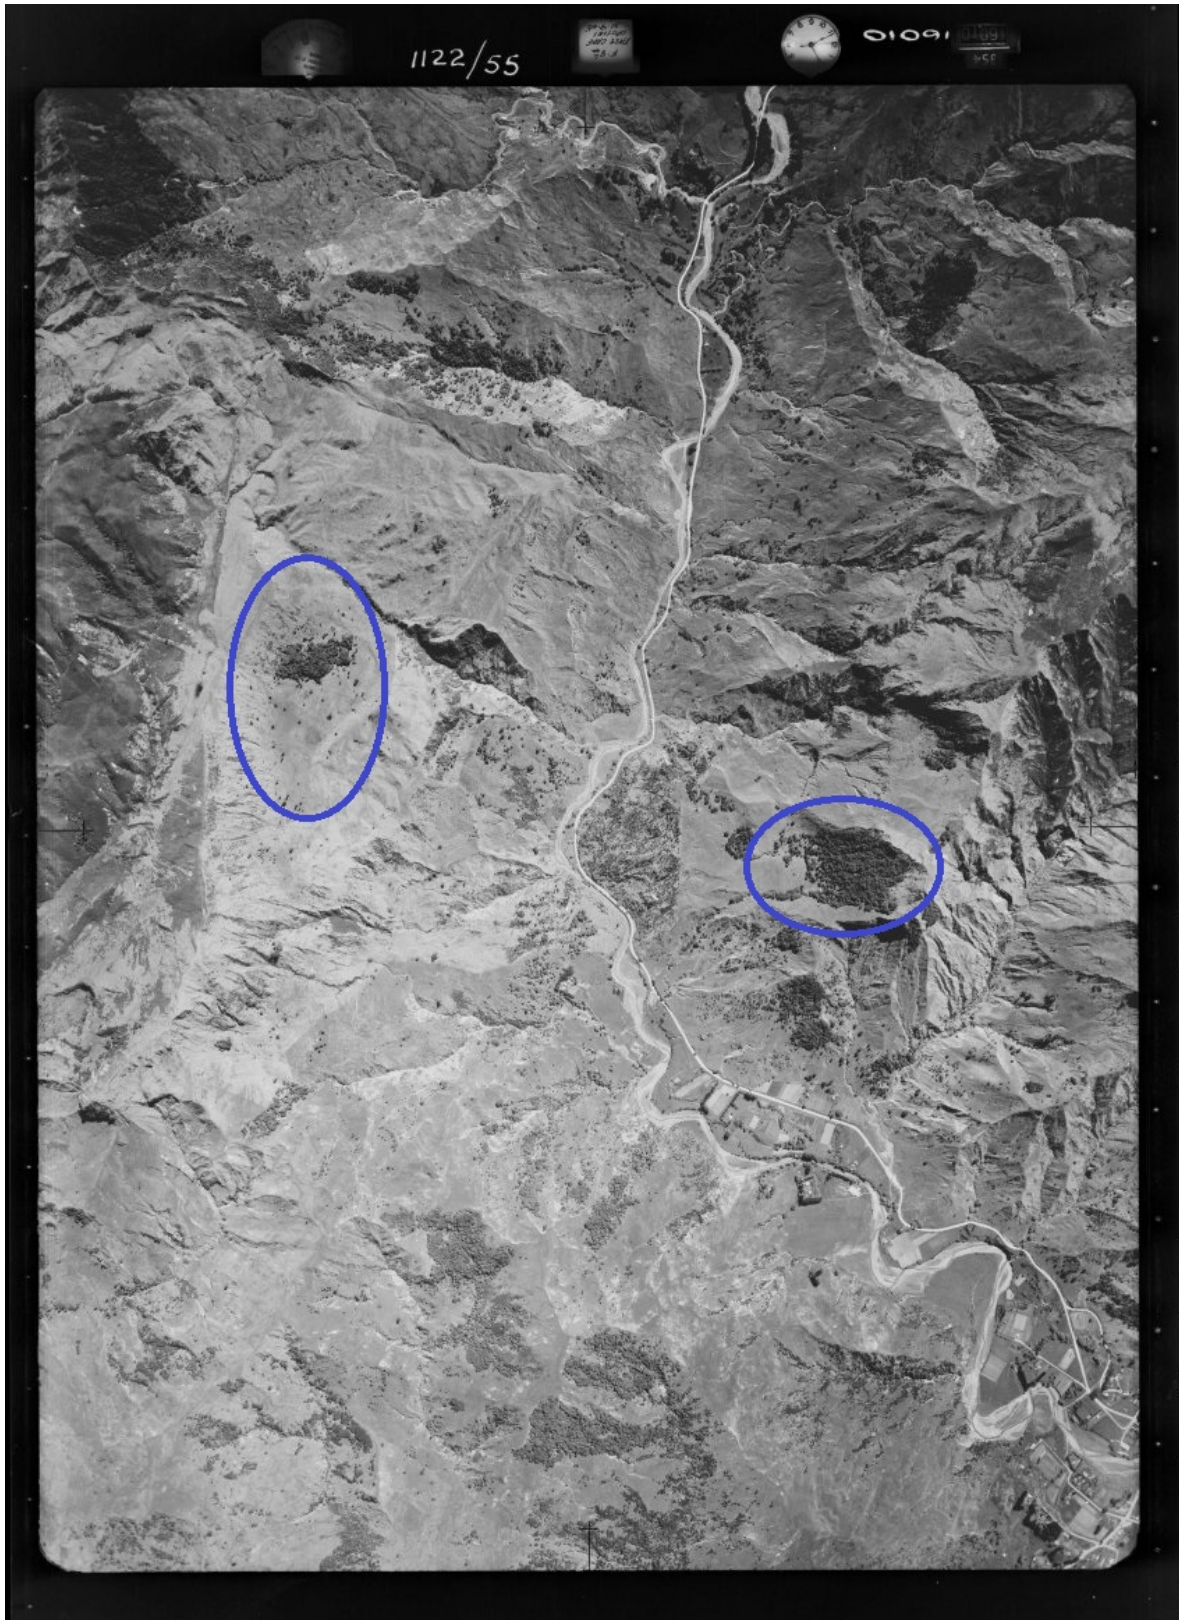
Fig 1

Close examination of this 1945 photo of the Mangahauini Gorge shows a series of large land slide features on both sides of the river. The areas outlined are the steeper main scarp and relatively level head of two of these failures.

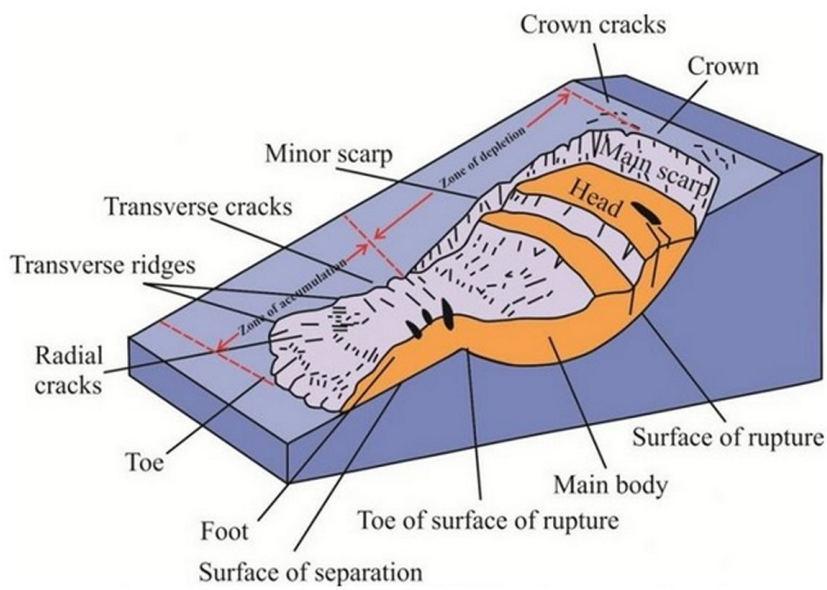
Fig 2

The following stylized diagram quite closely resembles the movement outlined in blue on the eastern side of the gorge.

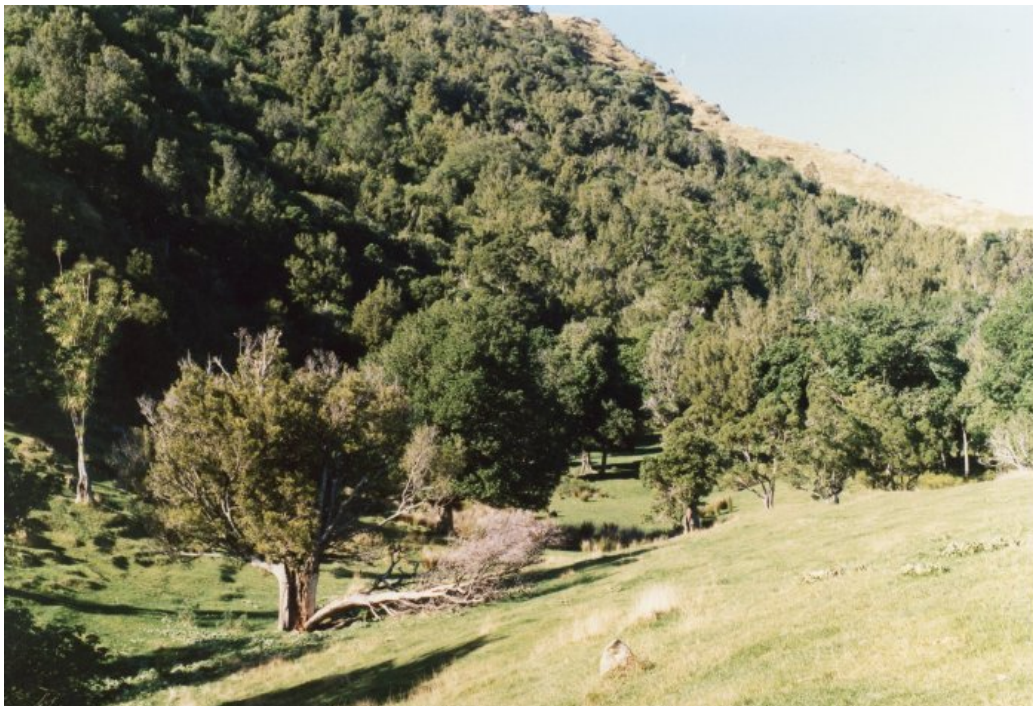
Fig 3 (1989 photo)

As I have been unable to obtain ground-based photographs of the western slope failures since Cyclone Gabrielle, I will use this **eastern** failure, on the opposite slope, as a proxy. The photo below, taken after Cyclone Bola, shows the relatively gentle contours of the head of the failure and the steep scarp behind clad in native vegetation. (See circled area in fig 1)

The head, in this case, is largely self draining, with little evidence of ponding of water. Infiltration in that area may, however, have contributed to the failure of the lower slope which blocked SH35 for some time after Bola. In the intervening 3 decades some observations have been forgotten! The main body of the **eastern** slope failure is seen here with typical disturbed ground contours. Of significance is the pine forest on the lower slopes on the **western** side of the gorge seen here. This area will be referred to next.

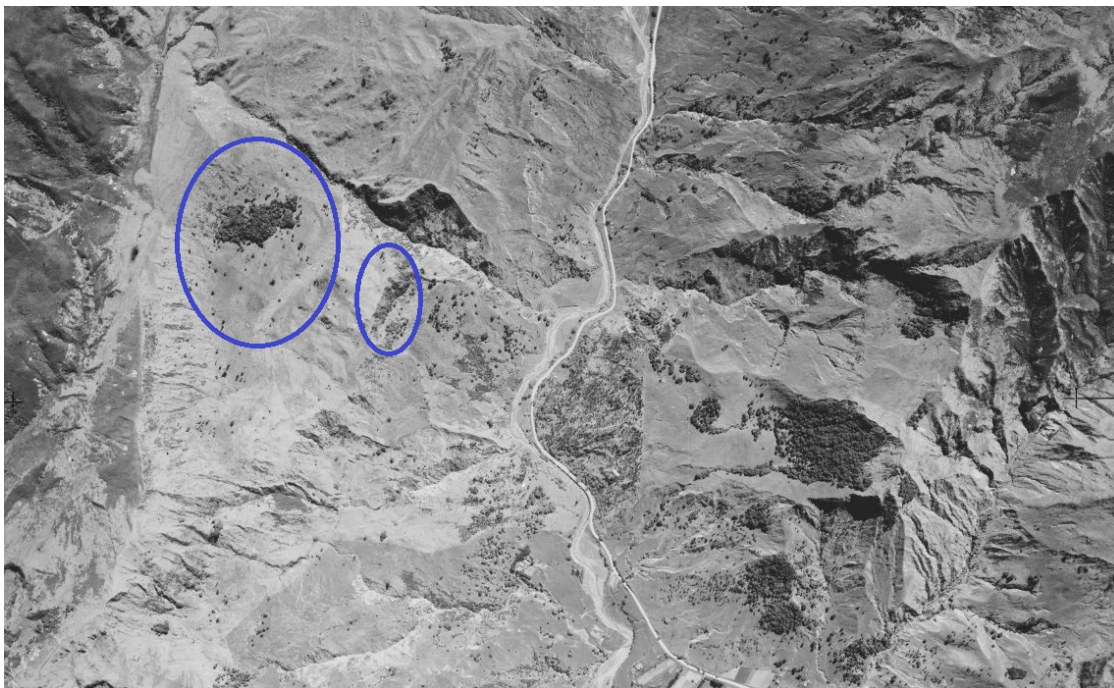
Fig 5

In fig 5 above I have again outlined areas of importance in this discussion, while in fig 6 below I have identified these features in greater detail.

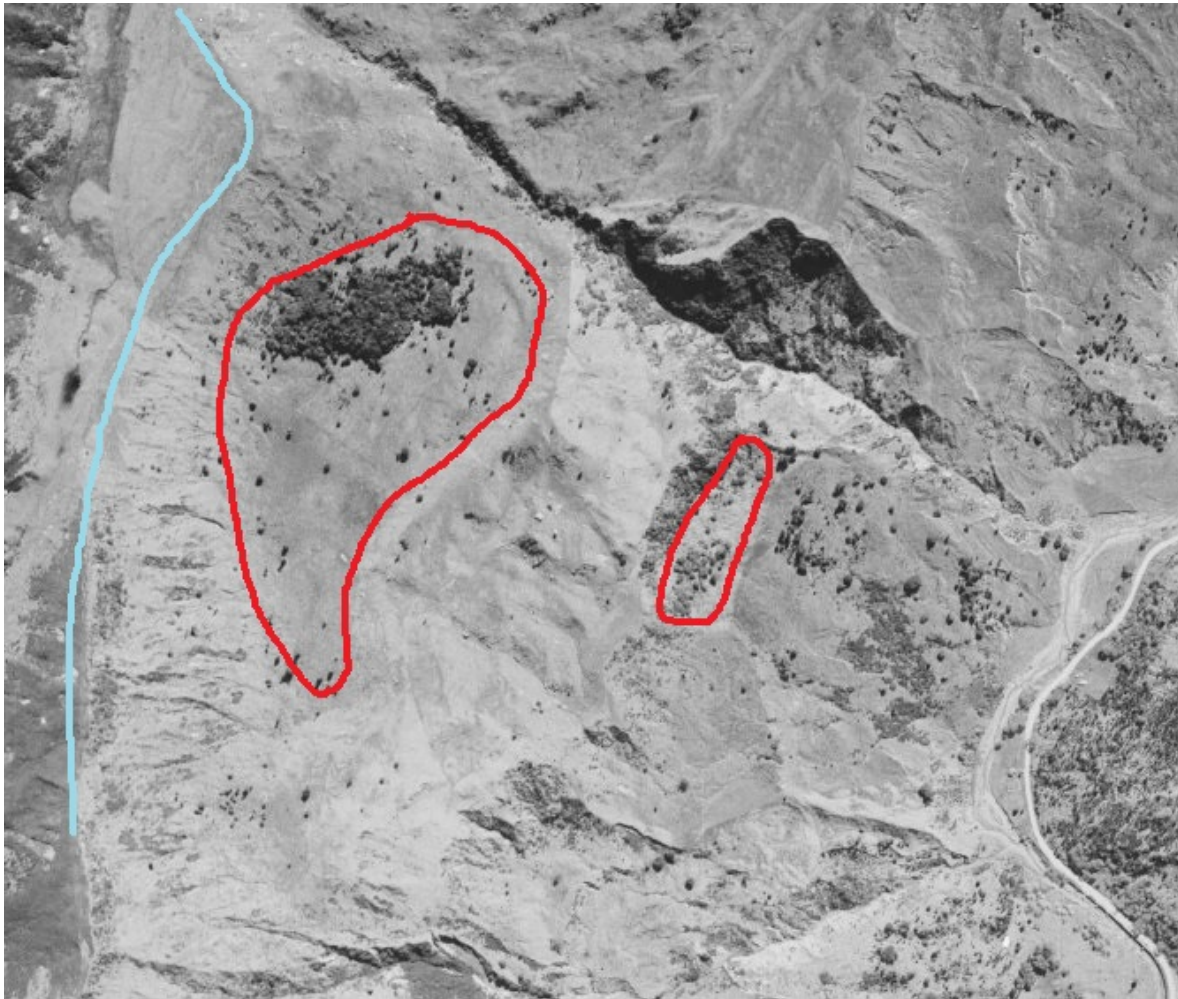
Fig 6

Ridgeline in blue. Main back-tilted head and ponding area and secondary back-tilted head in red.

The significance of the main back-tilted head as a potential ponding area and infiltration zone will become apparent in the imagery taken immediately after Cyclone Gabrielle. The smaller back-tilted head has unknown ponding capacity but is highly likely to also increase infiltration of rain water into deeper levels of the movement.

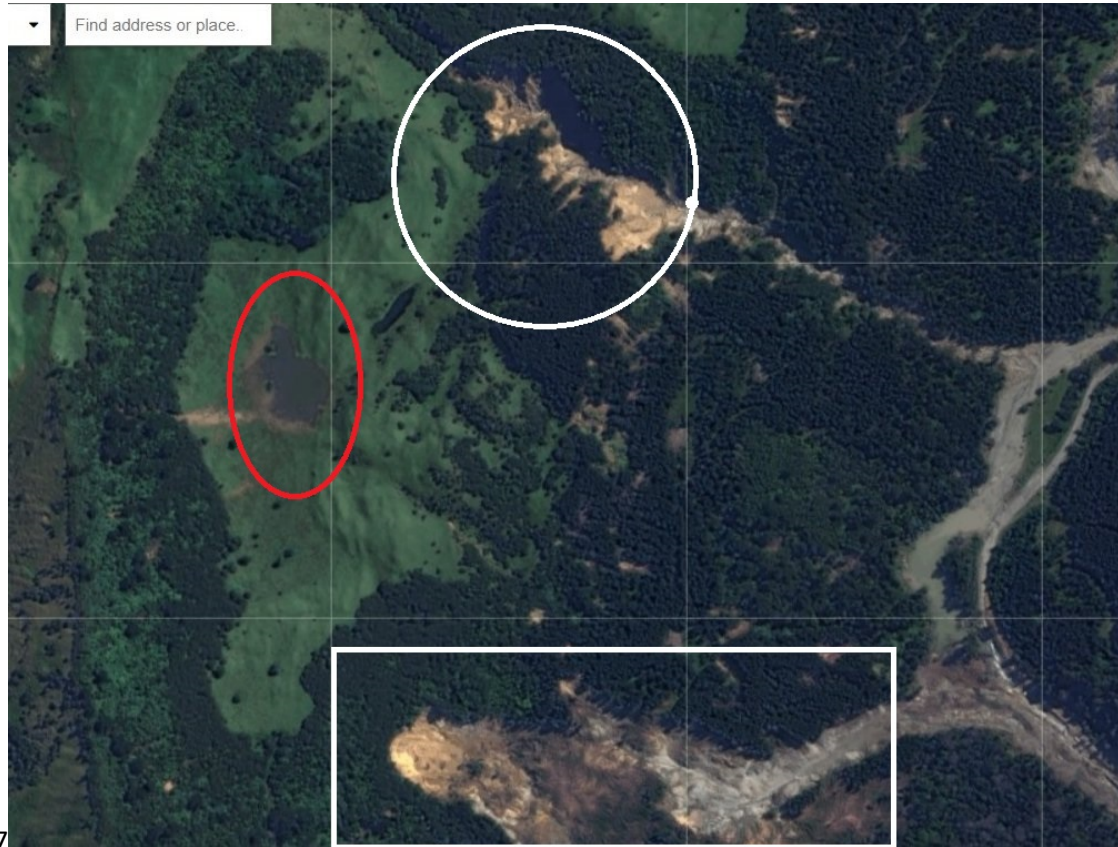
Fig 7

The post Gabrielle satellite photo seen below (fig 7) shows very clearly the significant volume of water pooled in the main ponding area of the slope failure in the Mangahauini Gorge that we are discussing.

Back-tilted head with ponded water in red. Reactivation of gullies within the main body of the historic slope failure in white.

The volume of water seen pooled here, plus the volume already infiltrated, as well as infiltration over the entire area of the historic failure, has been enough to trigger further movement.

2. Treatments could consist of the opening of surface drainage channels to ensure that water no longer ponds in these zones and the possible lining of such zones with an impermeable clay where they are of particularly permeable material.

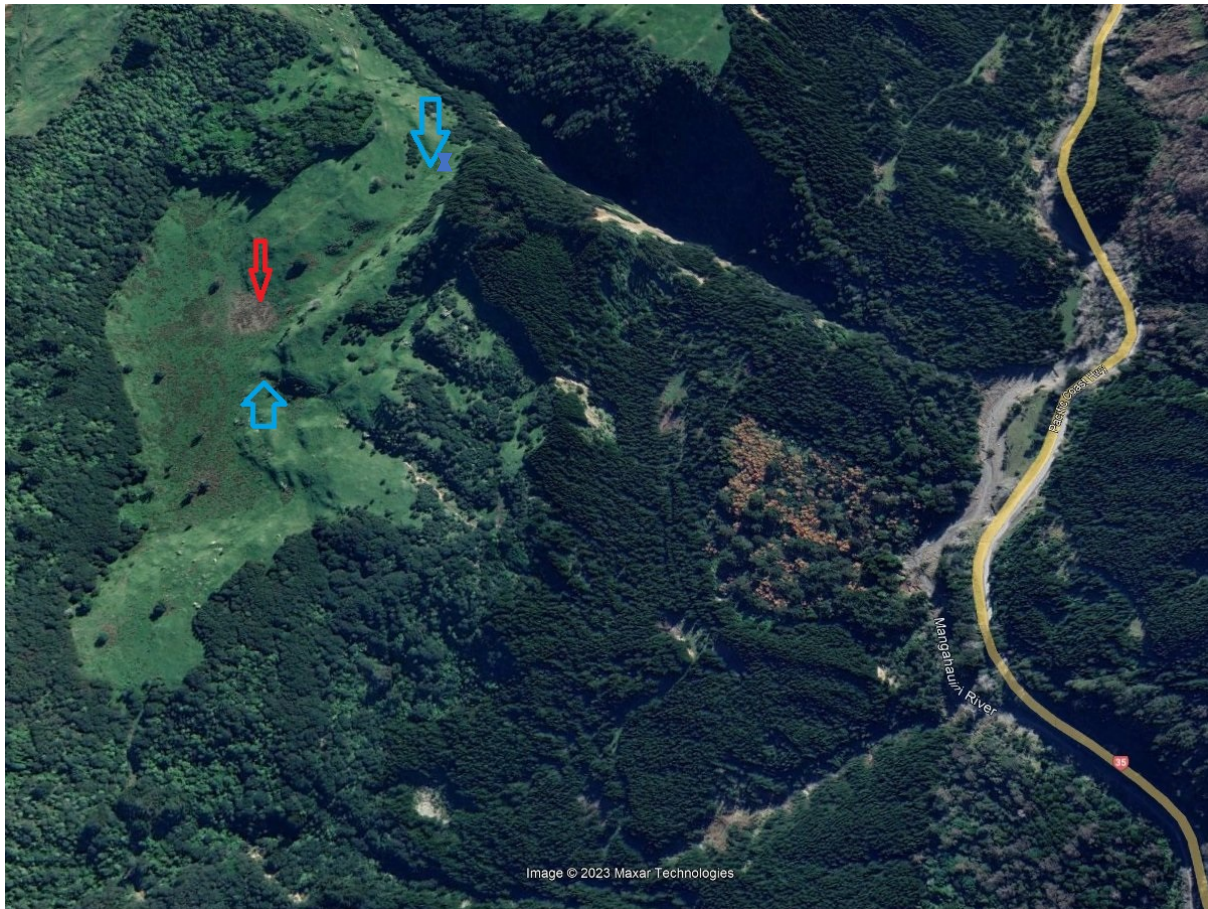
Fig 8

Current Google earth imagery (fig 8) shows signs of vegetation that may have been affected by standing water over a smaller area, which implies that it is a regular occurrence, but with worse impacts due to the extended period of frequent intense rainfall over the last year. Rough heights obtained from this imagery indicate that about a metre depth of water could pool during intense rain events, although an on-site survey is required for accurate results. A large proportion of that back-tilted head appears to have vegetation typical of very damp areas.

Vegetation affected by standing water in red. Likely existing surface outlets in blue.
